## **Rehabilitation of Housing for Disaster Affected People: A Case Study of Landslide at Chittagong, Bangladesh**

### **Abstract**

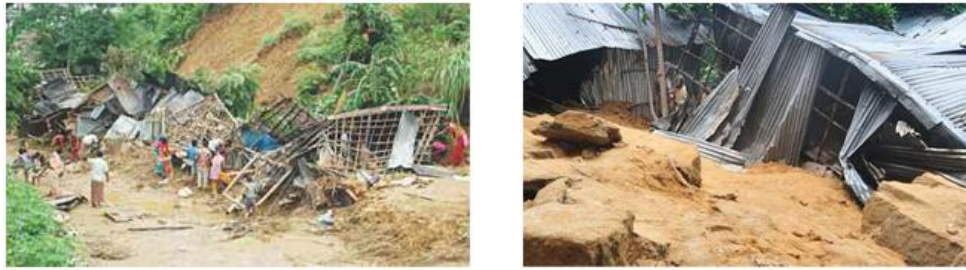
Figure 1: View of landslides in Chittagong

City since 1997, 15 landslides have killed nearly 400 people in the city and adjacent small urban centers. For example, the landslide disaster in June 2007 that was triggered by intense rainfall killed 128 people and affected 2,072 families in five informal settlements (Khan, 2008). After the massive landslide of 2007, a technical committee has been created of government agencies, Chittagong City Corporation (CCC), Chittagong Development Authority (CDA), researchers, engineers and NGO workers for identifying priorities for action, land use vulnerability assessment and zoning. That committee divided the city into 3 zones considering risk issues of the landslide.

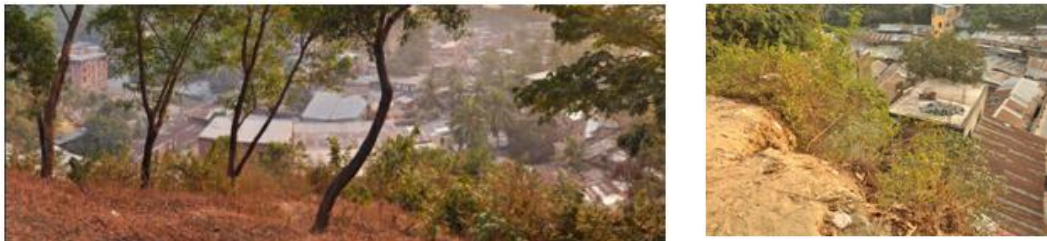
Figure 5: View of survey area 2

Figures 5 and 6 present the conditions and location of landslides in Survey Area 2 respectively. Various related information are provided here.
