Landslide in Chittagong City: A Perspective on Hill Cutting

Abstract

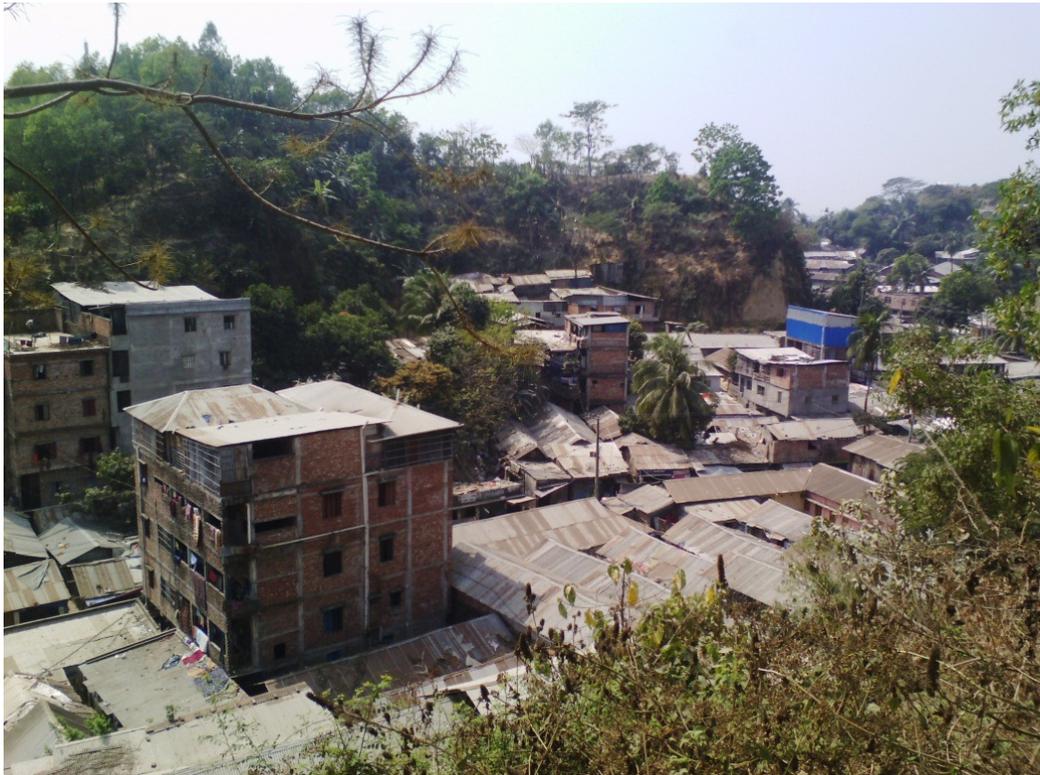
Despite a government ban indiscriminate hill-cutting is not stopped. Presently hill cutting is one of the major causes of landslide in Chittagong city. Hills of Chittagong is being cut for building construction, develop residential/housing area, clay and sand mining and developing road network. The Chittagong city is a densely populated area. For accommodation people build house on the top of the hills or on slope or on the foot of hills without following the existing rules and regulations (figure 9). Greedy influential people and muscle-men are invading the government hills and building temporary houses on them to earn money by renting them to the poor people. Poor people who live in those houses are highly vulnerable to landslide. Because of hill cutting, the slopes become instable. The hills of Chittagong were cut with slopes of 70-80 degrees (Mahmood and Khan 2008).

Fig 9: Showing the housing development happened on hill by hill cutting in Motojorna area.

When it rains, water dissolves the minerals of the soil of the hills that loosen its compaction. Soils of the hills also become heavy by absorbing rainwater. If rain intensity is too high, minerals of soil dissolve very quickly and the soil turns into mud and becomes very heavy. The steep slope of the hill cannot bear the mass weight of the wet soil or mud that results the landslide. The recent landslide in Chittagong city was the result of hill cutting and steep slopes of the hills. The most affected areas because of indiscriminate hill cutting are Khulshi, Panchlaish, Sholoshahar, Baizid Bostami, Foy's Lake, Lalkhan Bazar, Pahartali, Kattali and Polytechnic area (Mahmood and Khan 2008). Not only Chittagong illegal hill-cutting also happened in Cox's Bazaar, Khagrachari, Rangamati, and Bandarban districts for accommodation purpose. Now some question arises-What holds the hills together? Secondly, cutting the hills destroys their integrity, making landslides more likely. Hundreds of hills, even those owned by public or private, who are influencing to cut downhill? Thirdly, stemming the growing influx of ethnic Bengali migrants to the area, whose construction methods are invasive, and rehabilitating those buildings is constructed. Will the critical action in reducing the disaster threat posed by landslides? A table of some landslide that occurred by hill cutting has given below (table 3).
